E2 ISSUES - an EVOLVE TRIKES TECHNICAL GUIDE

2017-July

E2 owners and dealers have alerted us to the following particularly frustrating issues with the E2. This document includes guidance we have provided on the issues.

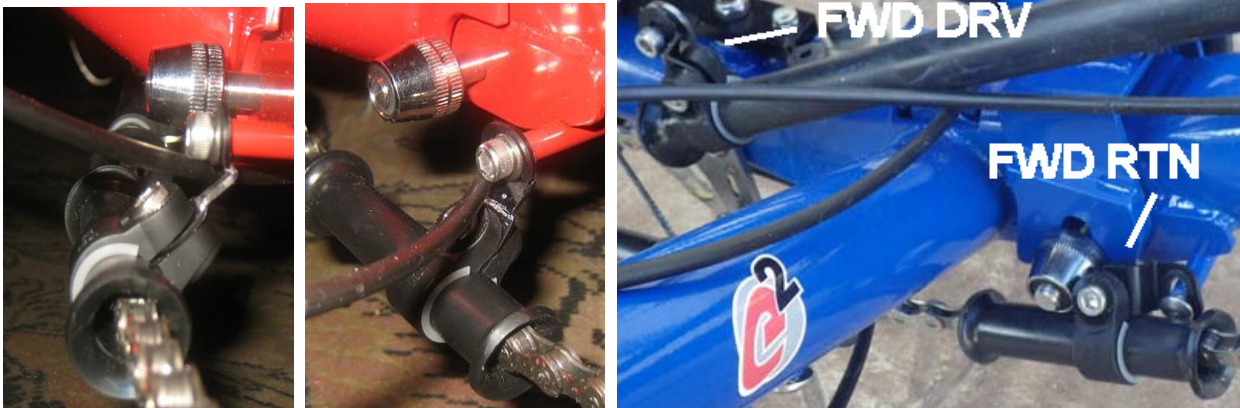
Our brackets are solid one-piece, but the E2's front two chain tube brackets are more vulnerable two-part, a plastic clamp and a thin folded steel plate hanger. The plastic part is more bulky increasing the

chance of interference and the thin metal plate more vulnerable. Because they have an approx 15mm inherent offset they cannot be arranged to emulate the geometry of our brackets. The two parts are also not reliably fixed relative to each other. When the plate rotates relative to the clamp the chain tube can drop by about 0.5inch (13mm), creating interference with other parts. More interference increases the chances of the brackets catching & bending/breaking.

E2 images, Red: bent bracket. Blue: plate rotated relative to the clamp with brackets labelled.

Unfortunately we can see no easy solution other than being careful not to force the folded trike backwards. One E2 owner reports that this works for him.

The alternative is replacing the E2 chain tube brackets with brackets fabricated to our design. Our brackets are more robust one-piece and we have never had any bending or breakage. See “Replacing the E2 forward chain tube brackets” below.

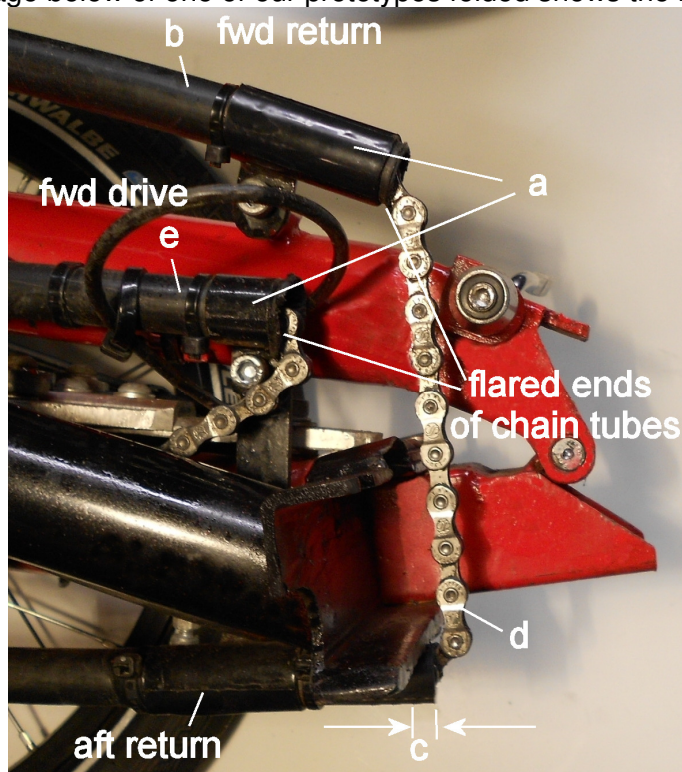
The image below of one of our prototypes folded shows the brackets set up as they should be:

Note that in the above image:

- The two topmost forward chain tube brackets are those we recommend replacing.
- the topmost (fwd return) chain tube is long enough to hold itself ~parallel to the boom,
- the front end of the lowest chain tube (aft return) extends ~3mm forward of the hinge,
- b+c ensures the unenclosed section of return chain always clears the cross-arm channel.
- the middle (fwd drive) chain tube keeps the chain path to the idler clear of the hinge.
- d+e allows the cranks to be rotated when folding the boom to put the right pedal bend the rear wheel without the chain damaging any paintwork.

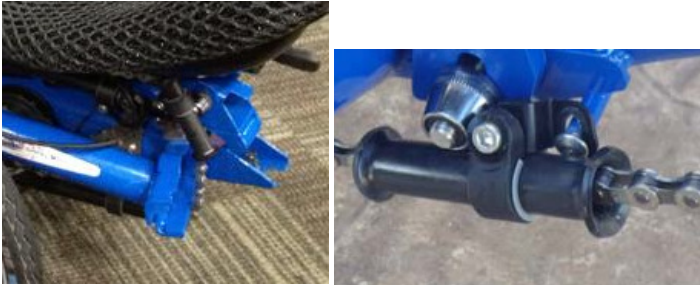
Left: E2 chain contacting the cross-arm channel,

Right: E2 FWD RTN bracket interference with Q/R nut

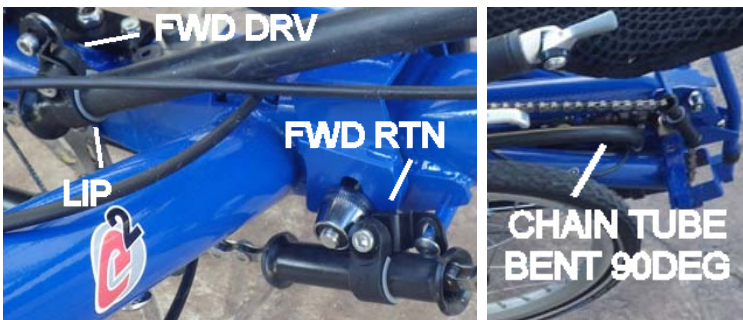
b. Forward drive chain tube severely bent when folding

The forward drive chain tube is bent 90 or 180 degrees when folding. The two parts of the E2 chain clamps are not reliably fixed relative to each other. When the plate rotates relative to the clamp the chain tube can drop by about 0.5inch (13mm), creating interference with other parts. When folding the boom back, the lower front lip of the Fwd Drive clamp catches behind the right cross-arm channel and prevents it rotating, causing the chain tube to be bent 180 degrees. The rear of the chaintube can extend back too far and get caught behind the right cross-arm channel, causing the chain tube to be bent 180 degrees, as can be seen in the right image below.

One E2 owner reports that the problem is avoided if he adds a step to the folding – he pulls the chain tube forward before folding.

The alternative is replacing the E2 chain tube brackets with brackets fabricated to our design. Our brackets are more robust one-piece and we have never had any bending or breakage. See “Replacing the E2 forward chain tube brackets” above.

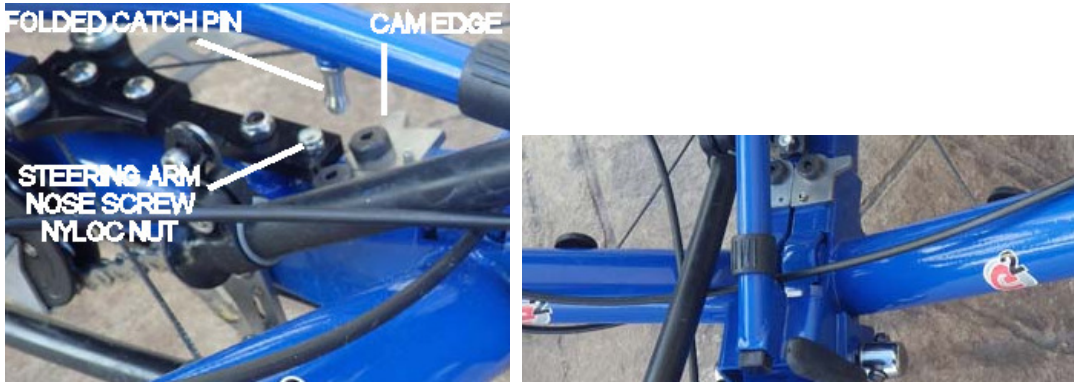
First, check that the nose of the E2 steering arm has a Stainless Steel Socket Head Cap Screw (SHCS) with head underneath and a nyloc nut on top. One E2 owner reports that fitting the screw resolved his issue. (see left image below.)

The right image shows some rubber bumpers that were added to the E2 to prevent paint damage from the steering arm movement. We presume they were added due to the absence of a proper screw in the steering arm nose and proper setting up.

Fitting screw to nose of the E2 steering arm.

If a Socket Head Cap Screw has not been fitted to the nose of the E2 steering arm we recommend fitting a Stainless Steel Socket Head Cap Screw (SHCS) M5x12mm from underneath and secured with an M5 nyloc nut on top.

Both the left and right hinge cam plate rear cam edges should engage the head of the Socket Head Cap Screw under the front of the steering arm to align that arm and keep the wheels straight when folded. With the steering pivot arm aligned along the main tube, the cam plate contact edges should just touch the M5 bolt head just as the cross-arms properly engage in the cross-arm catches. If the catches do not engage then the cam plate contact edges can be carefully gradually filed to suit. If it is too loose a larger headed SHCS would have to be substituted. After this, check and adjust the folded toe-in using our TECH-GUIDE_Toe-in-Adjust.

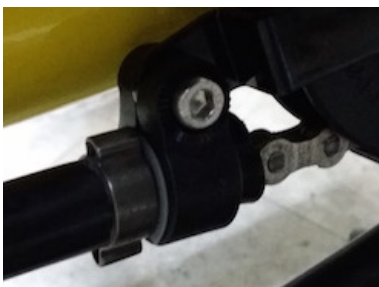
e Chain tube slipping through chain tube brackets.

E2 owners have reported that the chain tubes slip through the plastic chain tube clamps causing damage.

We recommend securing the chain tubes on the non-flared side with a firm [minimum 4.7mm (3/16in)] cable tie tightened with pliers, or as suggested by one E2 owner with a 15-17mm eared fuel hose clamp (as in image below).

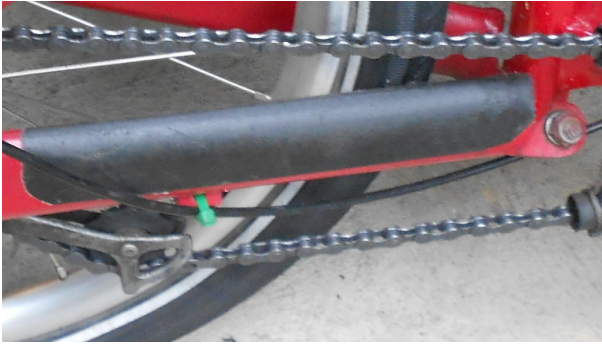
f Chainstay scratches from the chain when folding the rear.

E2 owners report scratches on the right chainstay when folding the rear.

We recommend fitting an approx 20cm(8in) length of cloth (book binding) tape over the right chainstay as shown:

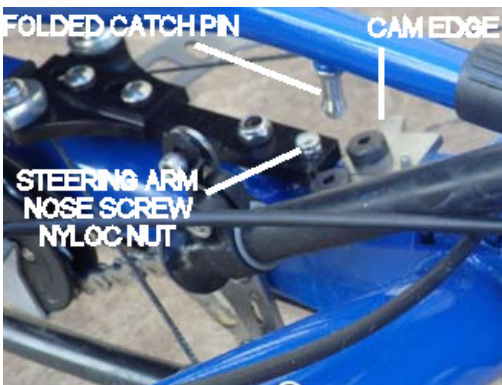
g **Folded catch and pin not reliable.**

At the outset we told CEW that they would need to source a stronger catch or have a thicker version fabricated, and neither of those happened. We suspect that the catch and pin used on the E2 wasn't as firm as ours.

An E2 customer reported his folded catch pin unscrewed itself and dropped out. The pin should be fitted using thread locker (Loctite etc) on the thread.

We recommend updating the catch with our updated catch design.

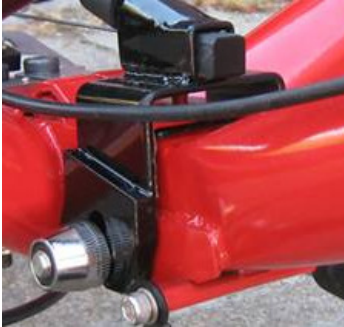
Overclamp channel

h **Quick Release always requires re-adjustment to fold.**

CEW chose to not bevel the lower edges of the seat arm over-clamp channel. We don't know if they fitted C-section plastic sleeve on the QR.

We recommend to file/grind an approx 4.6mm x 1.6mm chamfer on each side of each leading edges of the over-clamp channel.
