E2 ISSUES - an EVOLVE TRIKES TECHNICAL GUIDE

2017-July

E2 owners and dealers have alerted us to the following particularly frustrating issues with the E2. This document includes guidance we have provided on the issues.

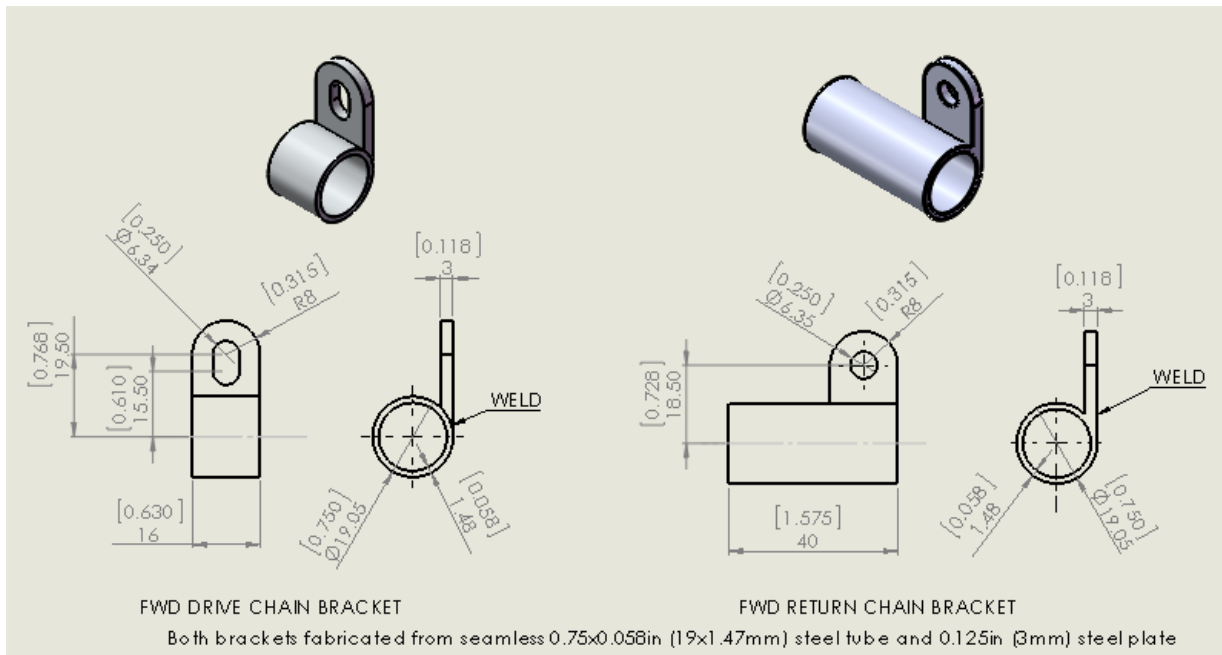
a. Bent or broken chain-tube support brackets

Our brackets are more robust one-piece and are much less vulnerable. If trikes with our brackets are rolled backwards the chain tightens and the trike stops rolling without damage. It takes major force to bend our brackets, and it has not happened in many years of normal use.
